Full Scale Experimental Test of the Girder-Slab Composite Floor System

Villanova University
College of Engineering
Structural Engineering Teaching and Research Laboratory (SETRL)

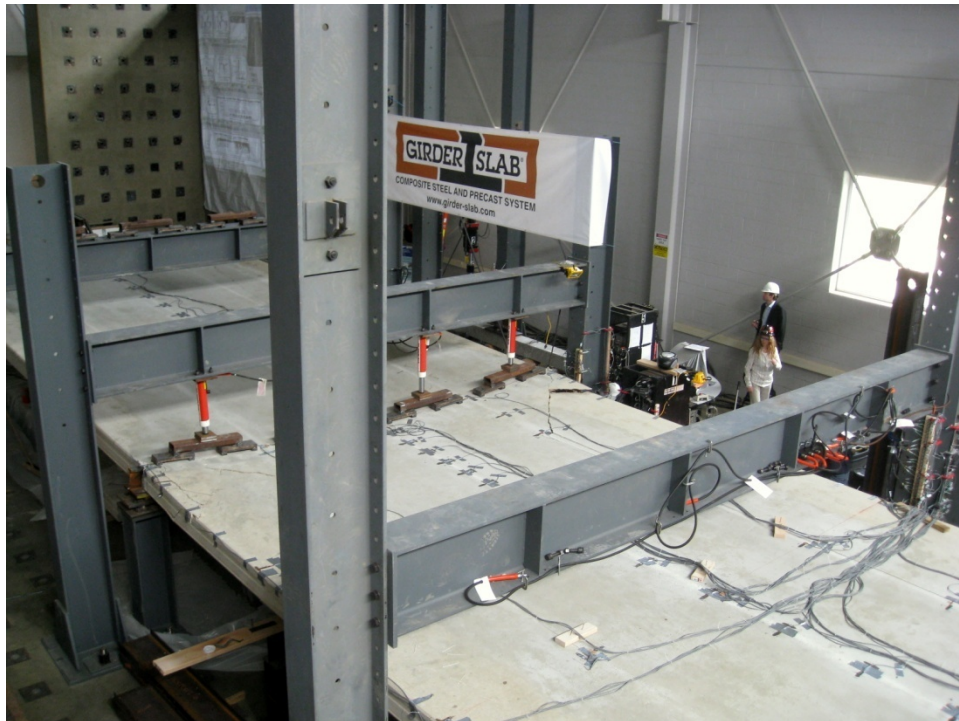
Figure 1: Overview of full-scale test setup

A full-scale test of the Girder-Slab composite steel and precast structural system was completed on April 30, 2009 at the 10,000 sq. ft. Structural Engineering Teaching and Research Laboratory at Villanova University. The objective of the research study was to observe behavior of the full-scale system under simulated field loading conditions. A variety of experimental measurements were made to evaluate load, deflections, and strains on the structural steel D-beams and surface of the hollow-core precast concrete slab. These measurements were used to evaluate strength and stiffness of the composite system. An overview of the test setup may be seen in Figure 1.

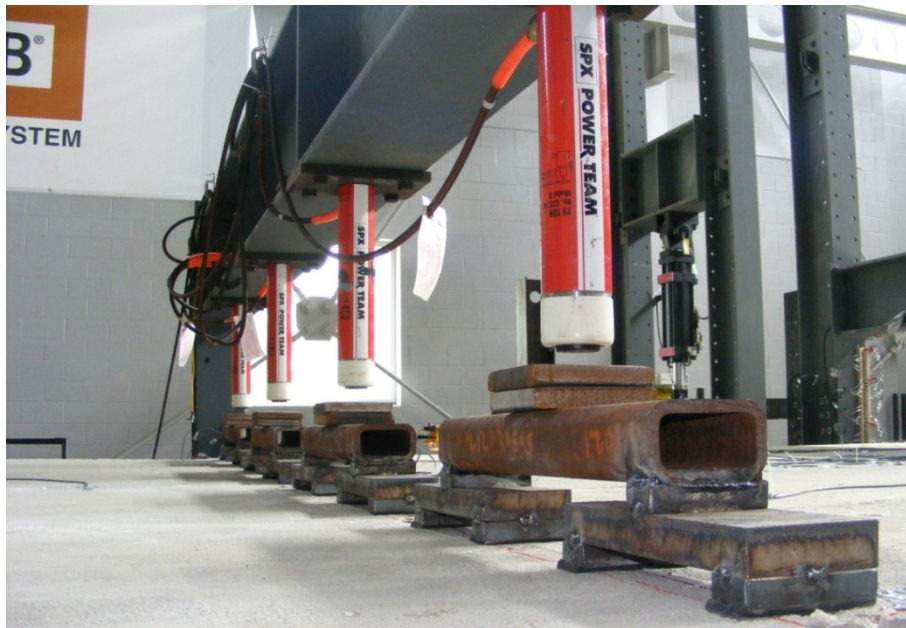
Figure 2: Hydraulic loading cylinders and load distribution elements

Load was applied to the full scale specimen using 25 ton capacity hydraulic cylinders spaced 4 ft. apart along the span of interest. The load from each hydraulic cylinder was then transformed to a uniform distributed line load using load distribution elements as shown in Figure 2. Uniform line loads were located either at midspan of the plank in either bay or over the interior D-beam. In total, nine tests were conducted on the full-scale specimen. Prior to the test to failure, the specimen was initially subjected to four initial service-level loadings corresponding to equivalent applied floor loads of 30 psf, followed by four identical tests to equivalent applied floor loads of 60 psf.

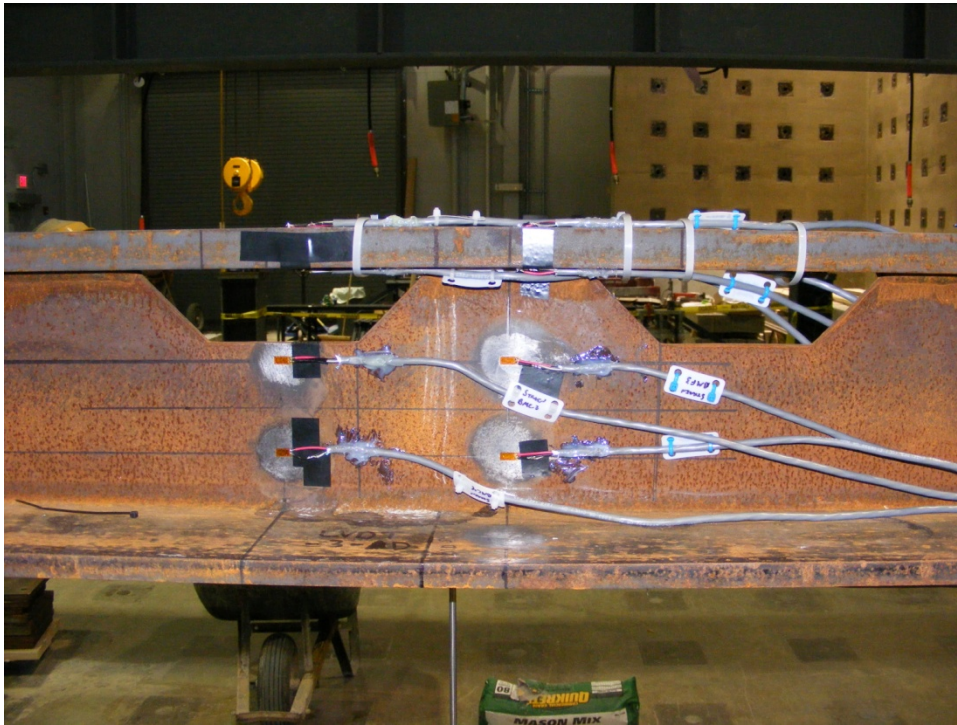
Figure 3: Instrumentation of the steel D-beam for strain measurement

Extensive instrumentation was installed on the specimen to measure support reaction forces, D-Beam and slab deflections, steel strains, and concrete surface strains. A total of 119 measurements were recorded continuously using a high-speed data acquisition system. An example of instrumentation used to measure steel strains can be seen in Figure 3. The measurements will be used to better quantify specific section properties of the composite system for design. These critical properties include effective width, section modulus, and moment of inertia, which are used to compute elastic flexural stresses in the composite D-beam/slab system, as well as deflection of the D-beam under service-level loading.

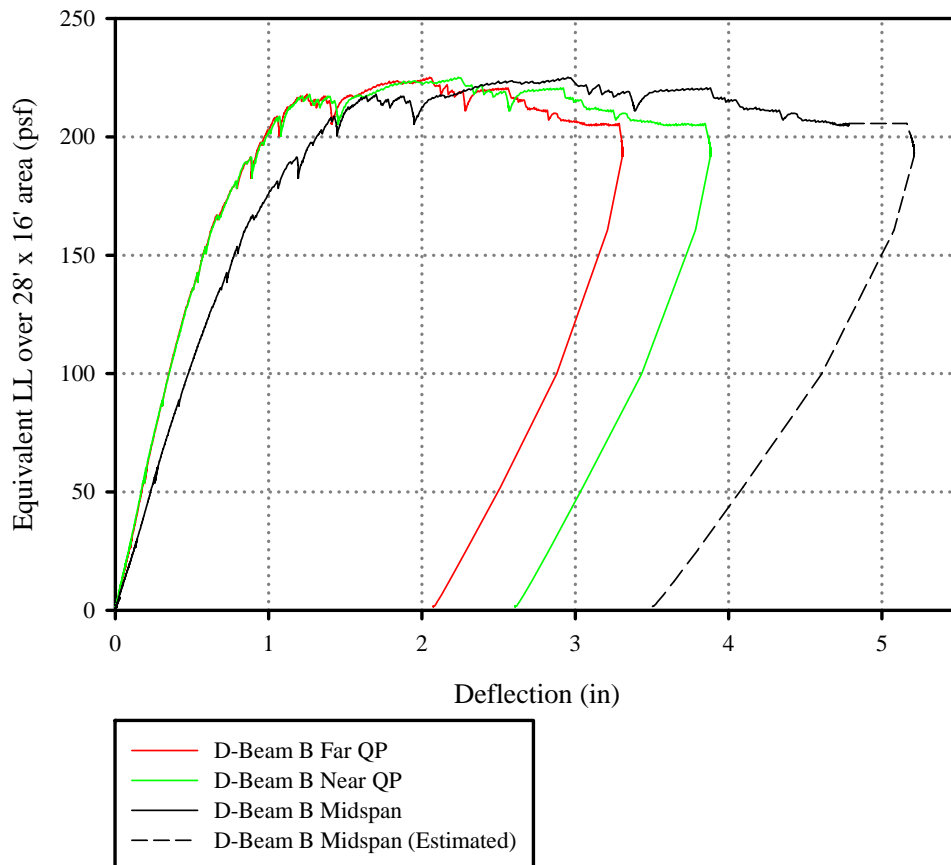
Figure 4: Equivalent floor load vs. interior D-beam deflection (test to failure)

A plot of equivalent applied floor load vs. interior D-beam deflection may be seen in Figure 4. The full-scale specimen performed extremely well during the full-scale test, and resisted an equivalent applied floor load of 225 psf prior to failure. This equivalent load is roughly four times a typical service live load plus partition load of 60 psf, and is in addition to the approximately 60 psf corresponding to the self-weight of the system. The specimen proved to be extremely ductile, as noted by the large deflections at failure shown in Figure 4.

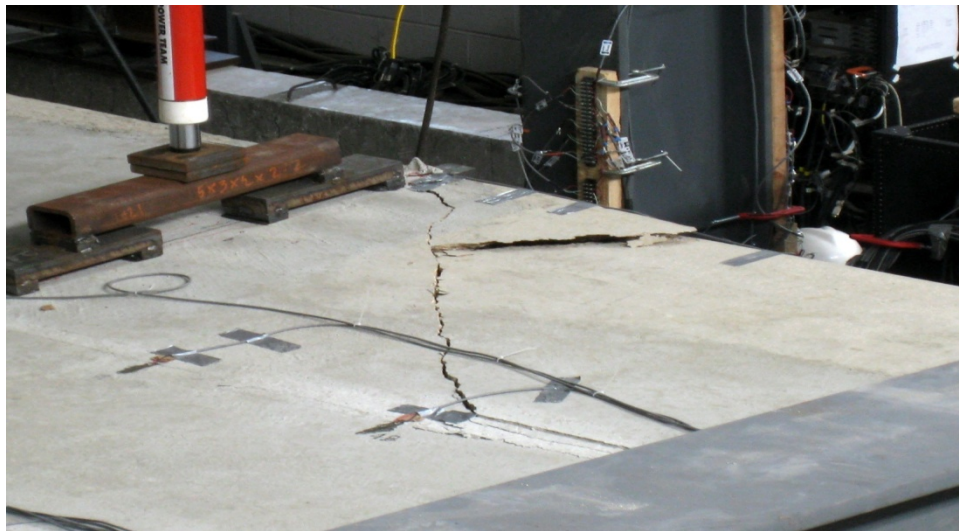
Figure 5: Failure of test specimen was defined by shear cracking of slab

Failure was defined by shear cracking of slab on either side of the interior D-Beam after significant yielding of the D-Beam. Shear cracking was first observed at an equivalent applied load of 191 psf, and continued to propagate under further loading. It is noteworthy that a true collapse condition was never achieved; rather the specimen was unloaded after the slab shear cracking caused severe distortion of the specimen, as shown in Figures 5 and 6.

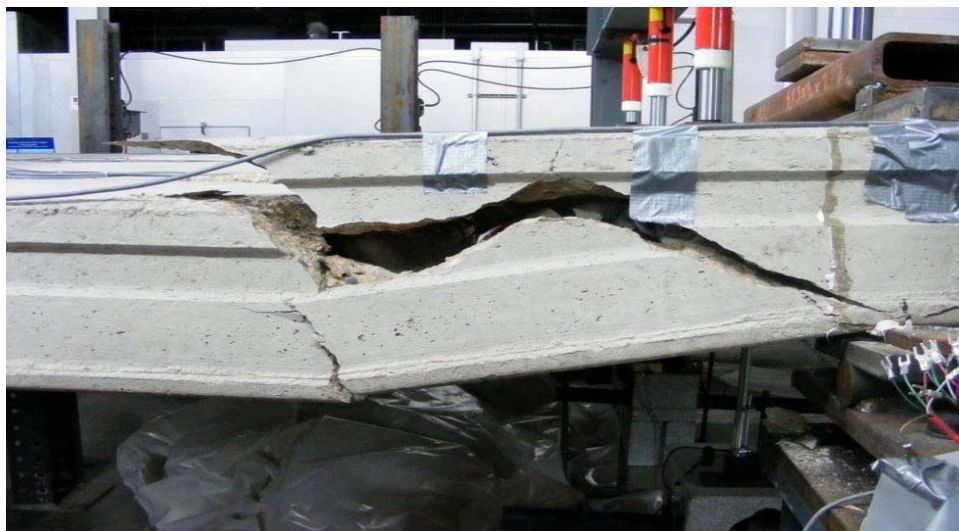
Figure 6: Test was stopped after severe distortion of slab due to shear cracking
